The NOAA -14 September 28, 2006(DOY271) Tumble Anomaly

Abstract—This paper describes a NOAA-14 spacecraft loss of control event and the lessons learned from it. The lessons learned are in two categories; Contingency recovery operations and on-orbit propulsion system isolation methods. The work is motivated in recognition of the effort of the NOAA off-line engineering support team and their NOAA civil servant mission leads and operations support staff

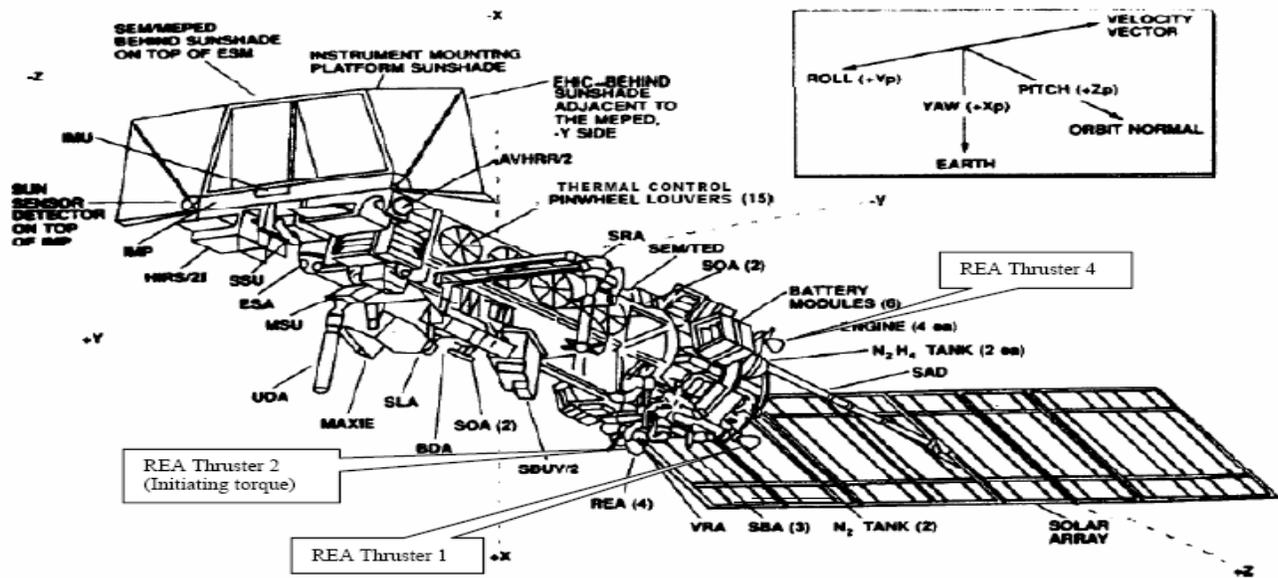
Figure 1-NOAA-14 REA Thruster Configuration and Plume Exhaust Direction

The cause of the tumble was not immediately understood from the indicators available in real time telemetry and event logs. However, by the following Monday (DOY 275), with the advantage of playback telemetry and experience with a similar type of event on NOAA-17 (Ref. 1) , it was determined to be a sudden release of propellant through the 100lbf hydrazine Rocket Engine Assembly (REA) #2. The evidence for this conclusion was a simultaneous step increase of $\sim 7^\circ\text{C}$ in the propellant line inlet and loop temperatures for thruster 2, coupled with the rapid 140 degree reverse motion of the solar array.. The prop line and loop temperature sensors are located at the entrance to the thruster valve and ~ 7 inches upstream respectively on the $\sim 3/8''\text{O.D.}$, $0.028''$ wall tubing (Ref. 2). The data also indicate a hydrazine leak which lasted ~ 45 seconds and affected the whole REA propellant manifold¹. This fact is substantiated by thermistor data indicating similar leak thrusts occurred at all 4 REA thrusters over the next 10 hours. Specifically, there were positive steps the inlet and loop thermistor temperatures at the times of Sunrise between 14:47 UTC and at the last step increase in the REA 3 thermistors at 23:56 UTC.

A representation of the NOAA-14 spacecraft is presented in Figure 1 annotated to show the REA thruster locations and to reveal their plume directions relative to the solar array.

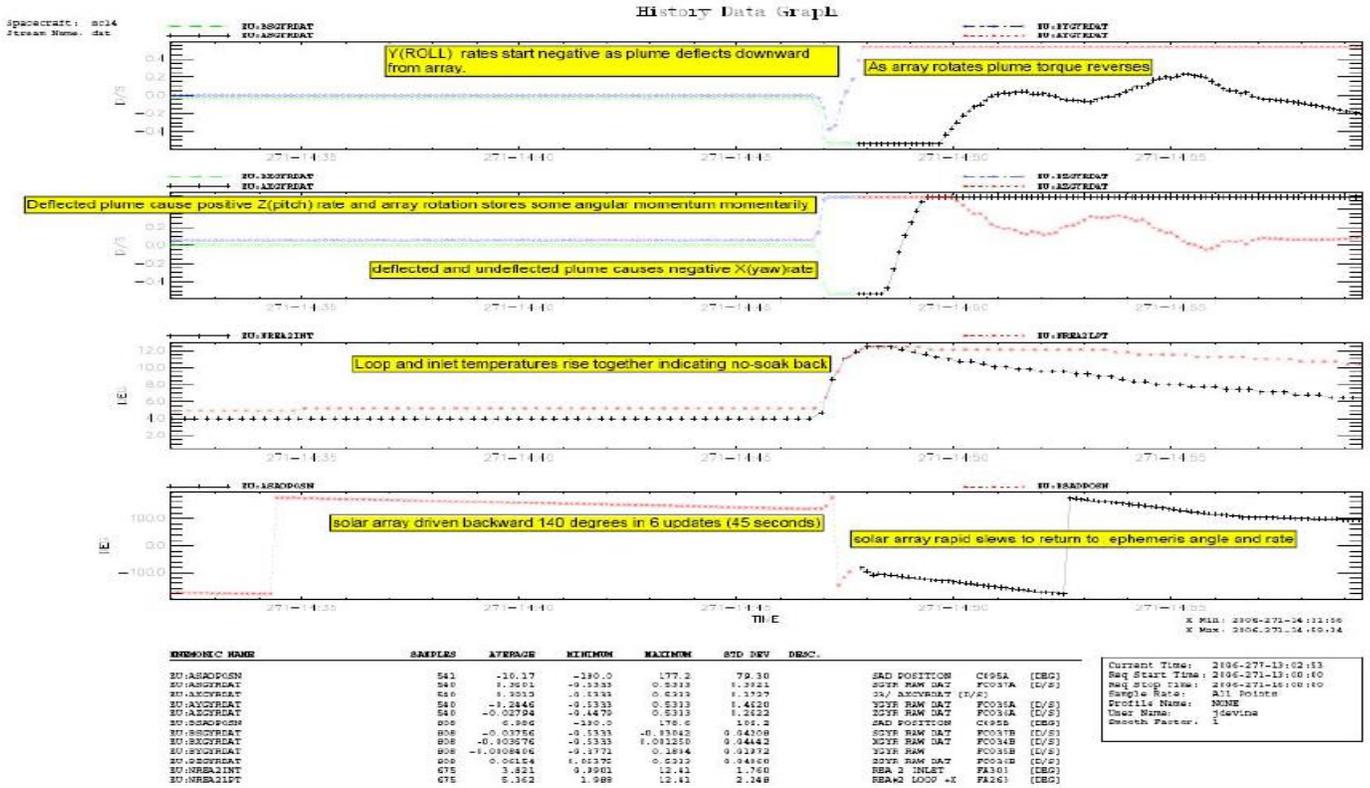
Figure 2-Unfiltered Body Rates, Line Temperatures, and Array Angles (30 Minutes)

The effect of the initial impulse on the body rates and solar array angle are illustrated in Figure 2. Notes on Figure 2 highlight the correlation between the step changes in the body rates, thruster 2 loop and inlet temperatures, and the solar array encoder angle. The data before the event is from the B and A data buses which were swapped by the On Board Computer (OBC) a few seconds after the beginning of the event. The short term evolution of the body rates is explained by the time dependent plume deflection from the windmill forced reverse motion of the solar array and its high rate return slew to the normal position and rate. The inlet and loop thermistor signals rise together, uncharacteristic of soak back heating from the

combustion chamber. The solar array encoder data shows that forced reverse motion of the array was 140 degrees in approximately 45 seconds.

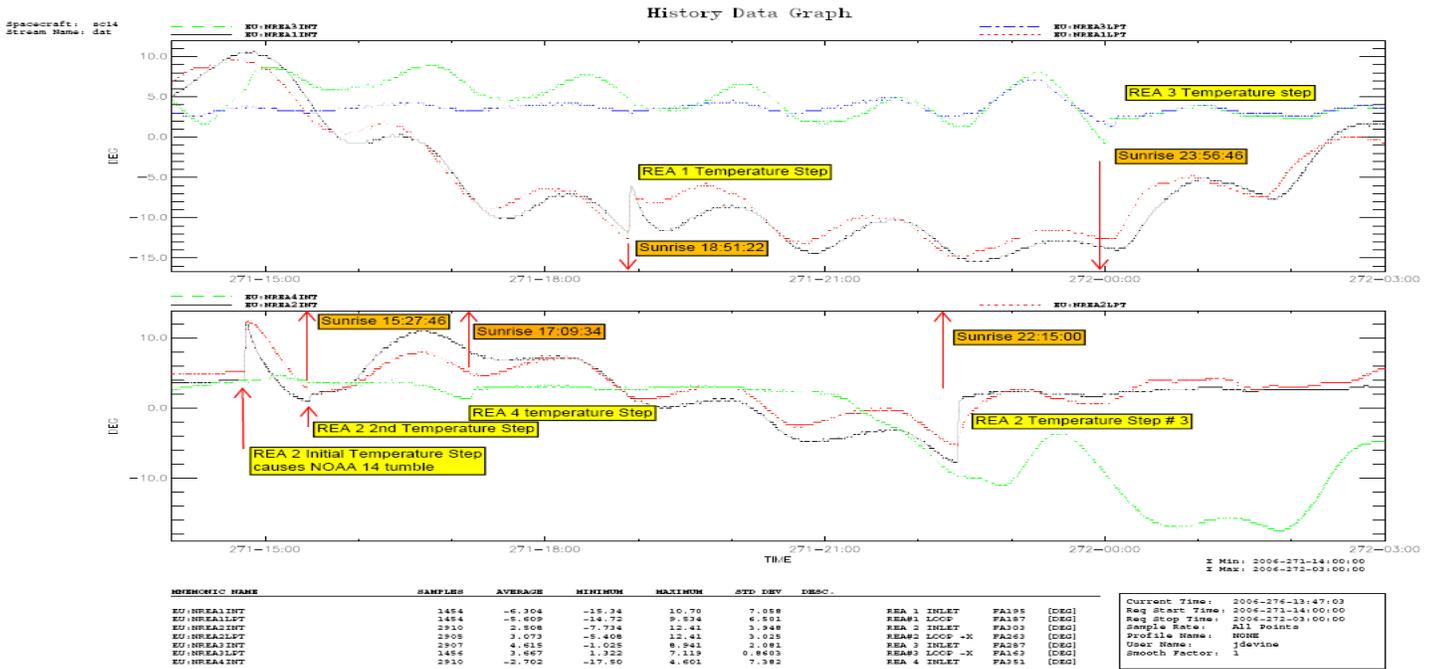
Figure 3-REA Thruster Temperatures For 13 Hours During the Event

Figure 3 shows the unfiltered body rate telemetry for 13 hours ending with the Earth capture. The y-axis (roll) rates which are saturated in this telemetry were determined to be approximately -0.9 deg/sec using the solar array current signal to determine the principal axis spin rate (I_{yy} near anti-parallel to +roll). Figure 4 shows the thermistor temperature data for all four REA thrusters for the time interval corresponding to Figure 3 revealing additional temperature step rises correlated with sunrise times. One explanation of this is that hydrazine ice from low level leaks at each of the thruster valves sublimates at sunrise causing ignition of the vapor at the catalyst. Also a detailed look at the rise times and delays between inlet and loop thermistors reveals evidence for combustion within the propellant line tubing.

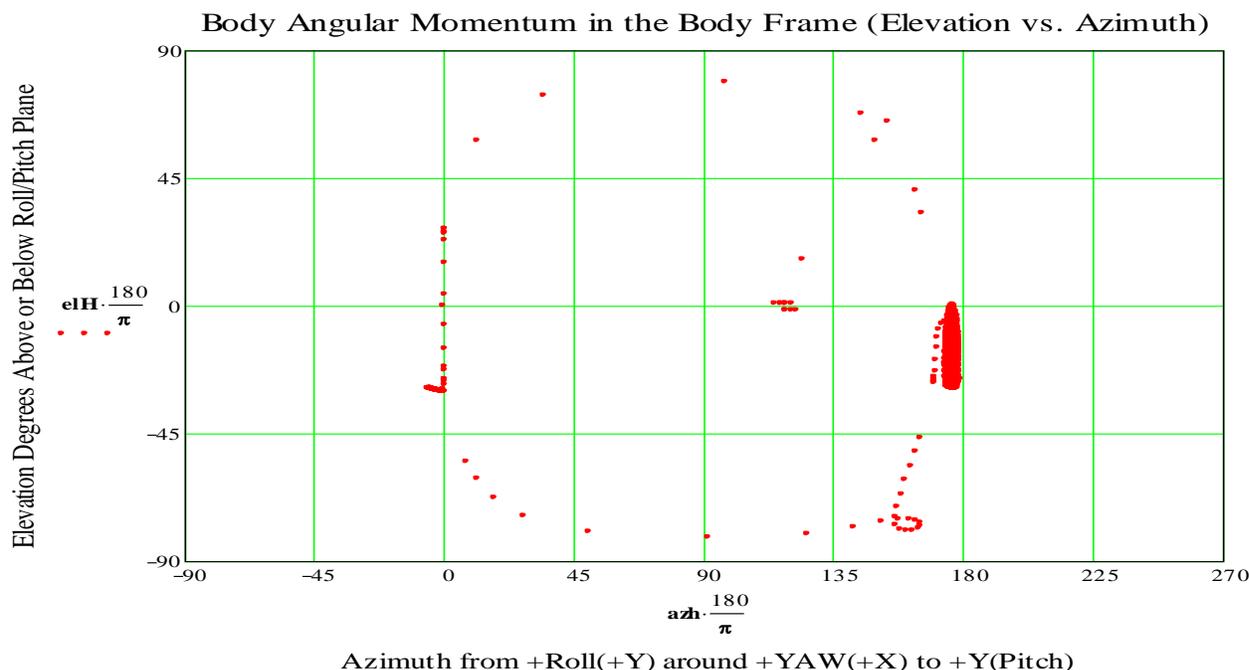
Figure 5-Total Spacecraft Angular Momentum in the Body Frame From 14:47 to 22:30 UTC

Figure 5 shows the evolution of the angular momentum vector in the body frame. More accurately, assuming that the torque free motion occurs within 5 minutes of the initial impulse, Figure 5 illustrates the motion of the body frame around angular momentum vector which is inertially fixed in a direction close to the orbit plane and the Earth north pole. This data is derived in three steps; 1) A recovery of saturated roll rates using solar array current to determine total spin rate 2) Multiplication of this reconstructed body rate vector by the deployed MOI, from (Ref. 2 and 3) Unitization of the unit angular momentum vector and translation into body frame azimuth and elevation.

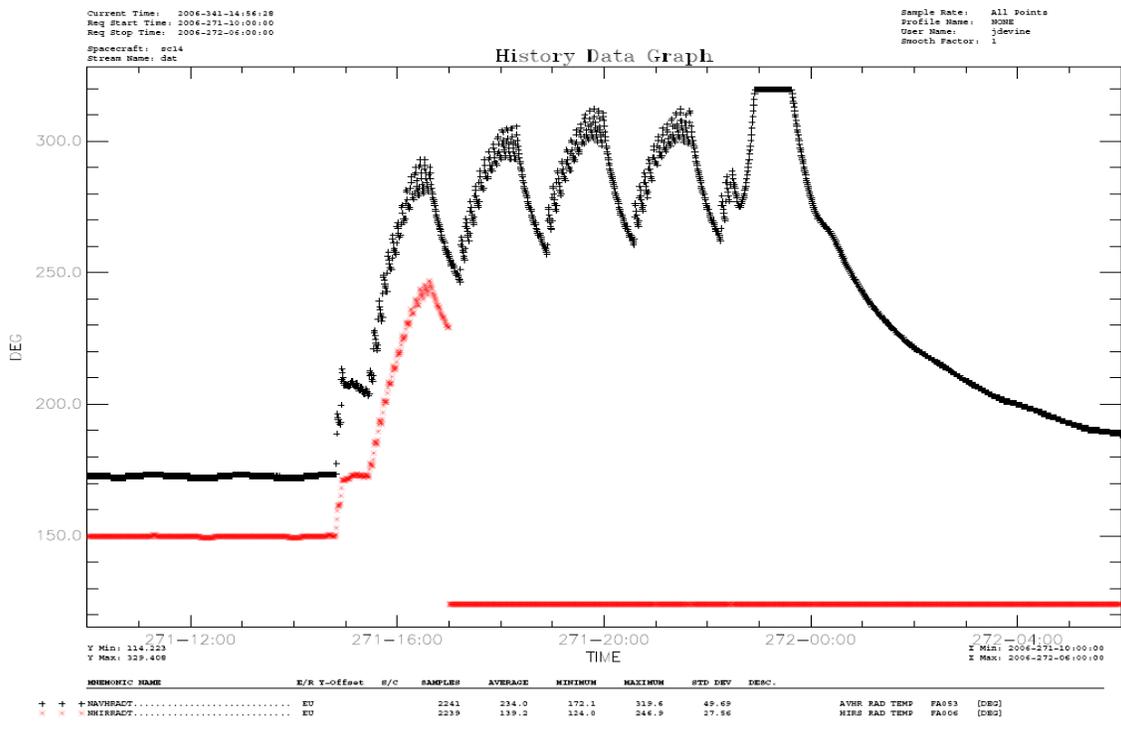
Figure 6-AVHRR Radiator Temperatures for 20 Hours Spanning the Event

the y-axis to illustrate the similarity of each orbit and repetitive nature of the spin phase. Figure 7 shows that the history of the Advanced Very High Resolution Radiometer (AVHRR) radiator temperature throughout the event. In the figure, the long period rise and fall are correlated with spacecraft day and night, and the short noise-like saw tooth oscillations are due to the spacecraft spin as the radiator passes the Earth and/or Sun during day or night. Finally, after the de-spin at 22:30 UTC the ending geometry has the radiator aperture illuminated by direct sunlight for approximately 40 minutes.

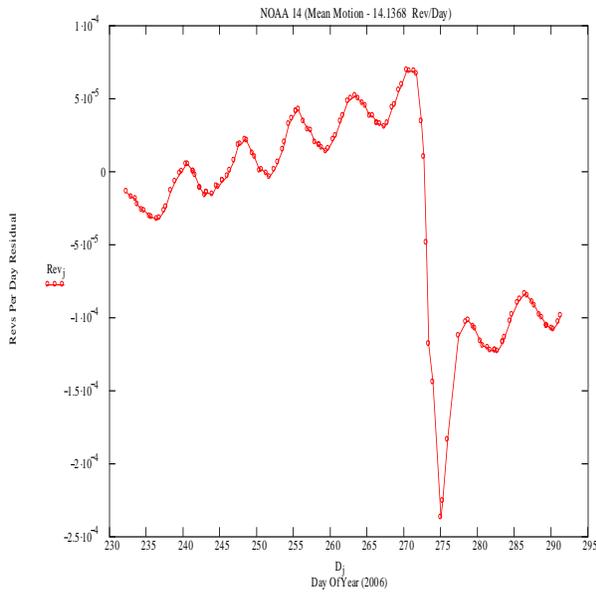
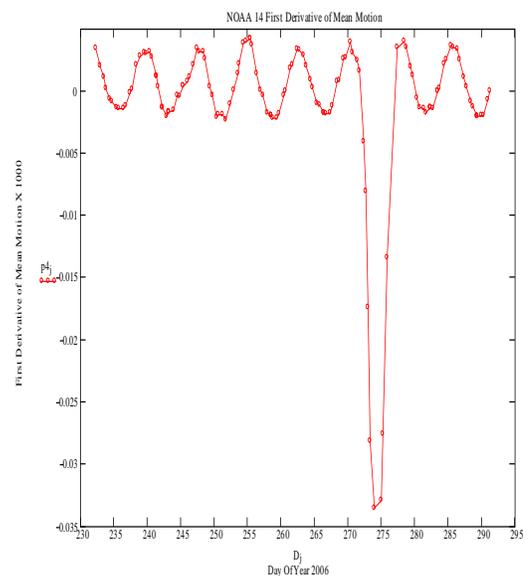
The NORAD Two Line Elements for 60 days including the event were analyzed to investigate the effects on the orbit. Figures 8 and 9 shows a discontinuity in the mean motion parameter and the corresponding impulse in the first derivative of the mean motion. From these data it was determined that the along track delta-V was +0.026 meters per second corresponding to a 0.65 Newton force applied for 45 seconds.
