The NOAA -14 September 28, 2006(DOY271) Tumble Anomaly

Abstract—This paper describes a NOAA-14 spacecraft loss of control event and the lessons learned from it. The lessons learned are in two categories; Contingency recovery operations and on-orbit propulsion system isolation methods. The work is motivated in recognition of the effort of the NOAA off-line engineering support team and their NOAA civil servant mission leads and operations support staff

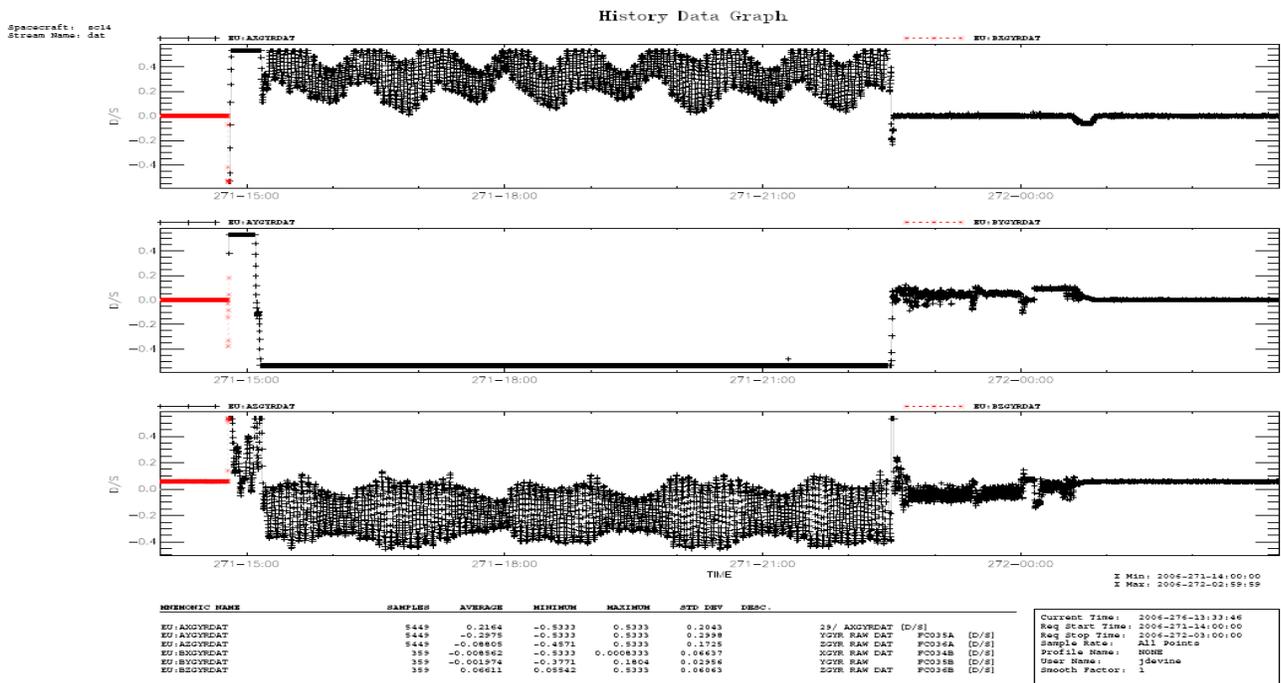
Figure 4-3 Body Rates from 14:00 UTC to 03:00 UTC (D272)

Figure 3 shows the unfiltered body rate telemetry for 13 hours ending with the Earth capture. The y-axis (roll) rates which are saturated in this telemetry were determined to be approximately -0.9 deg/sec using the solar array current signal to determine the principal axis spin rate (I_{yy} near anti-parallel to +roll). Figure 4 shows the thermistor temperature data for all four REA thrusters for the time interval corresponding to Figure 3 revealing additional temperature step rises correlated with sunrise times. One explanation of this is that hydrazine ice from low level leaks at each of the thruster valves sublimates at sunrise causing ignition of the vapor at the catalyst. Also a detailed look at the rise times and delays between inlet and loop thermistors reveals evidence for combustion within the propellant line tubing.
